LUNAR ORBITER V

MISSION SYSTEM PERFORMANCE

THE *BOEING* COMPANY

BOEING DOCUMENT D2-100755-3

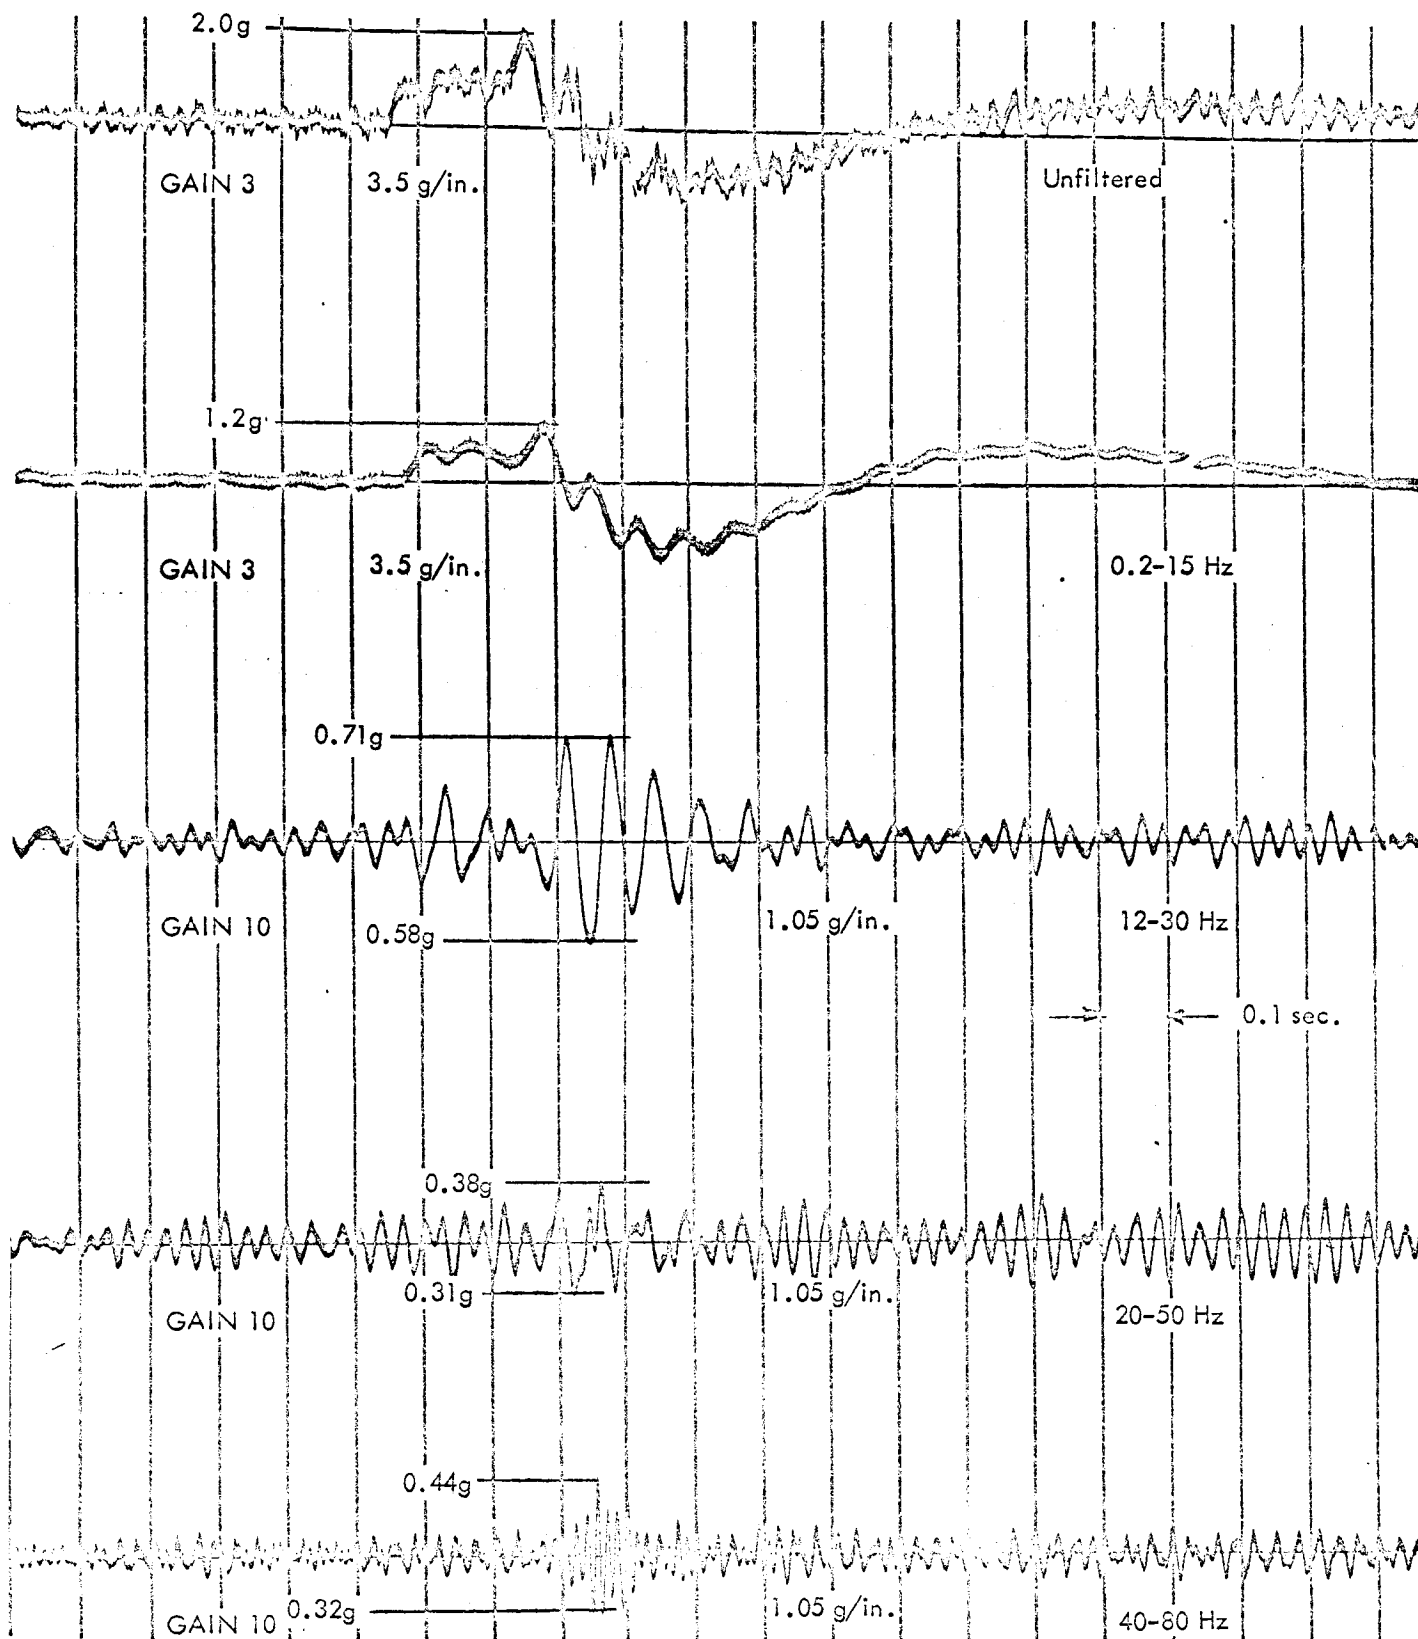
Figure 3-15. DECO Longitudinal Vibration (214x)

Figures 3-9 through 3-26 present vibration data (as recorded from Agena telemetry) from liftoff Day 213, 22:33:00.338 GMT to Agena second cutoff at 23:05:48.0 GMT. For comparison, the upper envelope of spacecraft vibration testing is included. These data are comparable to that observed during previous flights.

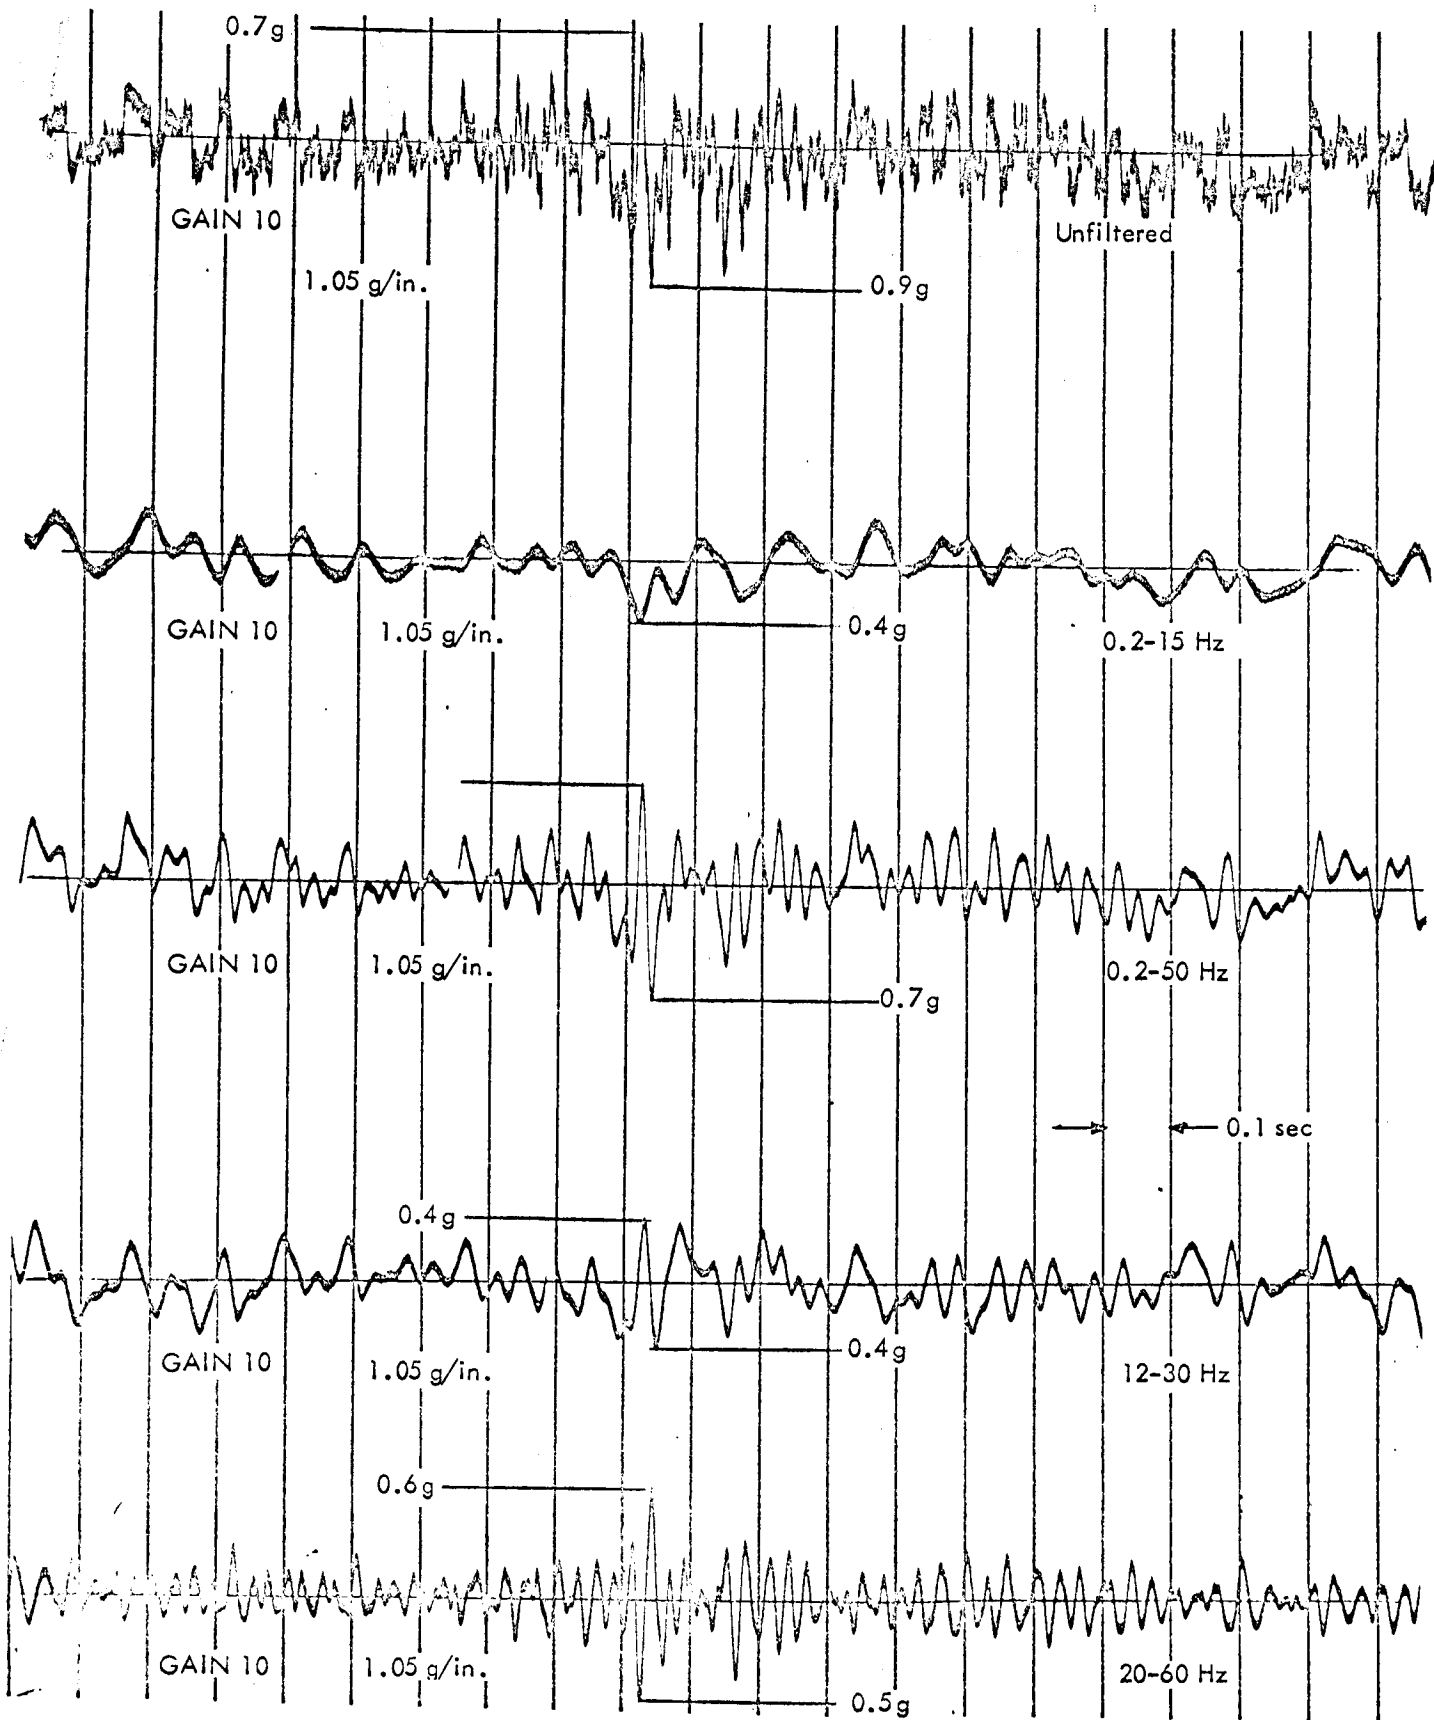
Figure 3-20: Agena First Ignition — Lateral Vibration (210z)
